Southwest Brooklyn
Industrial Development Corporation

Red Hook Small Business Hazard Mitigation Case Study Findings Report

September 2013

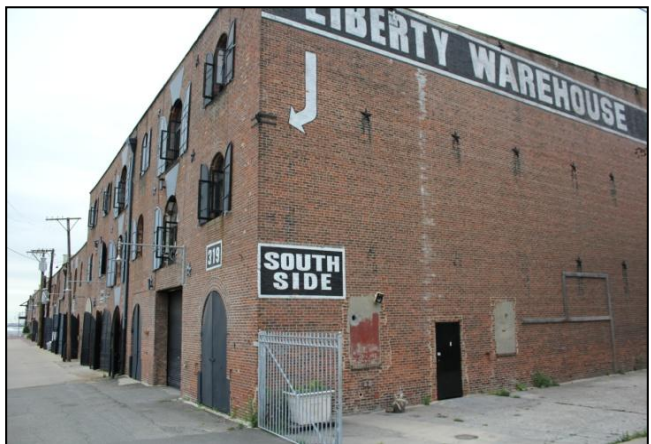
Figure 2 – Redeveloped warehouse building near Van Dyke & Ferris Streets

Red Hook's history as a port and trading center provides a legacy of large, strongly built warehouse and manufacturing buildings along or close to the waterfront. Many of the large warehouse buildings pre-date the Civil War, and were built using unreinforced masonry bearing walls and heavy timber interior framing. Similar buildings constructed from the late 1800s onward appear to also have been constructed using masonry bearing walls with structural steel interior framing. Many of the warehouse buildings have been redeveloped and leased to small manufacturers, professional service firms, and specialty contractors (Figure 2).

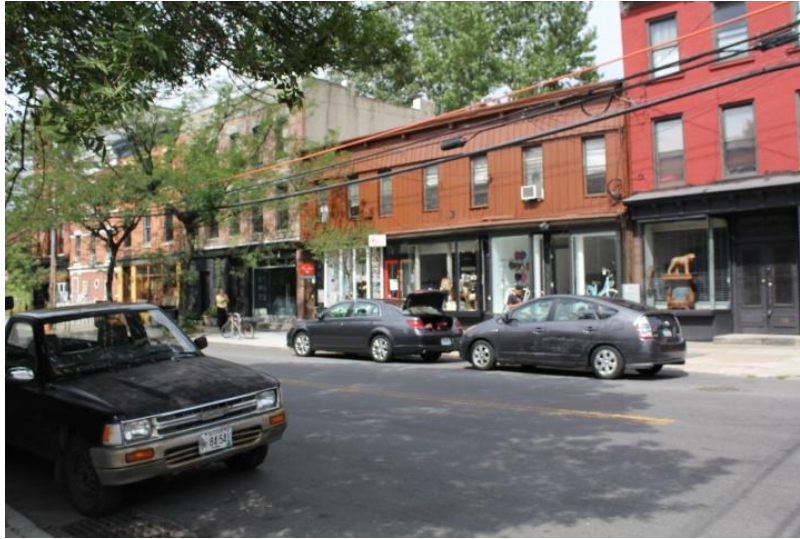
Figure 3 – Mixed-use commercial and residential development

Residential and light commercial structures are generally built with masonry exterior walls with wood frame interiors (Figure 3). These buildings held up during Sandy but were still vulnerable to flooding, as detailed later in this report. Some commercial buildings have basements with direct outside access through sidewalk hatch doors (Figure 4).

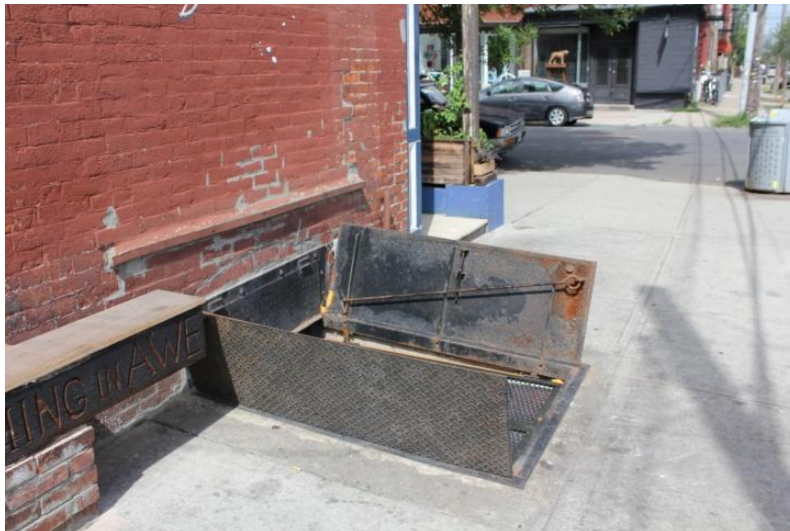
Figure 4 – Sidewalk hatch entry to commercial basement storage area

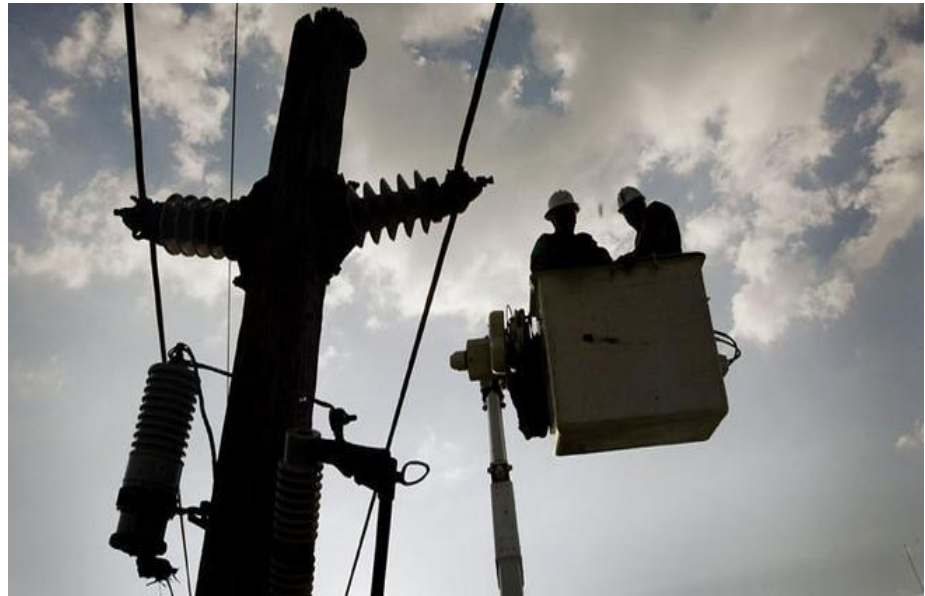
Figure 5 - Utility workers repair electrical and telecommunications lines after Sandy

Electrical service is provided by Consolidated Edison (Con Edison) of New York. Electrical service distribution in Red Hook is primarily through overhead conductors. Service ties are typically overhead taps to the building, dropping to the meter and service panel. Water and sewer service is provided to all buildings by the New

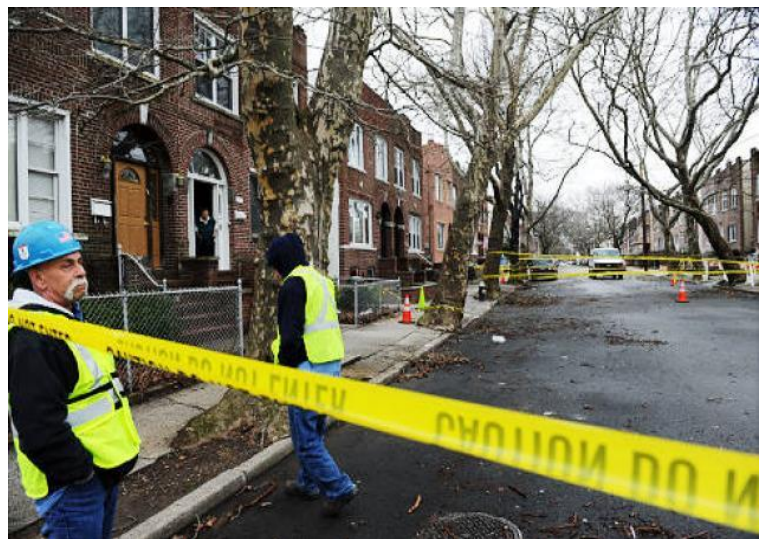
Figure 8- Tree debris impacts electrical overhead lines in Brooklyn, July 2013

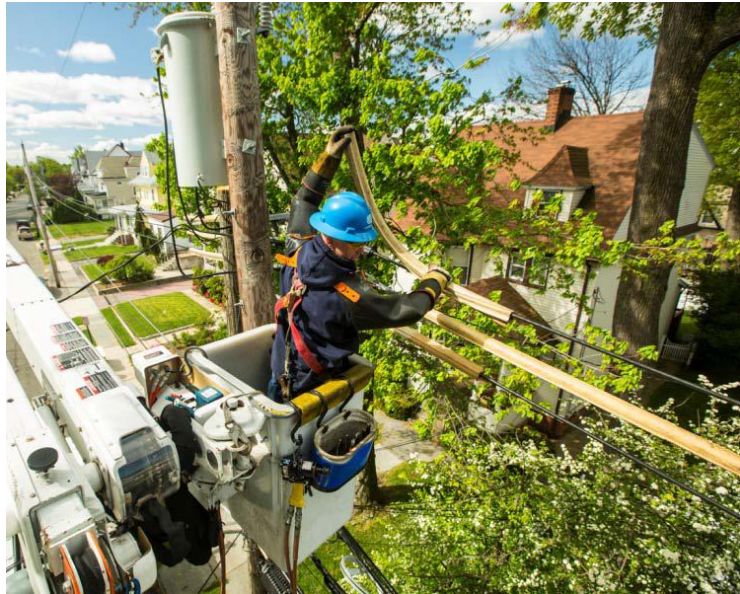
Figure 10 – Con Edison workers replacing damaged poles, transformers, and reconnection lines

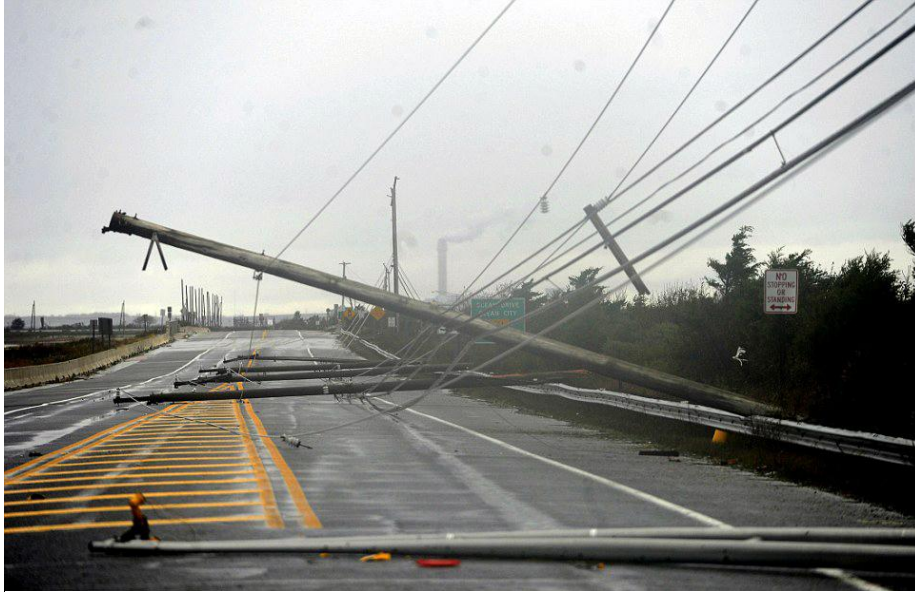
Figure 11 - Downed or severely damaged power lines threatened roads throughout the Sandy-impacted region.

- Loss of electrical power to more than over 811,000 customers in New York City and Westchester County, along with more than 940,000 customers on Long Island (Figure 11)
- A major fire caused by an exploding electrical transformer that destroyed 111 buildings and damaged 20 others
- More than 100,000 homes destroyed or severely damaged
- Extensive damage to transportation infrastructure, including two subway tunnels that were out of service during repairs (Figure 12):
 - R line serving southern Brooklyn, expected to be closed until October 2014
 - Greenpoint Tube on the G line, which has been restored to service but is scheduled to be closed for five weeks during summer 2014 to complete repairs

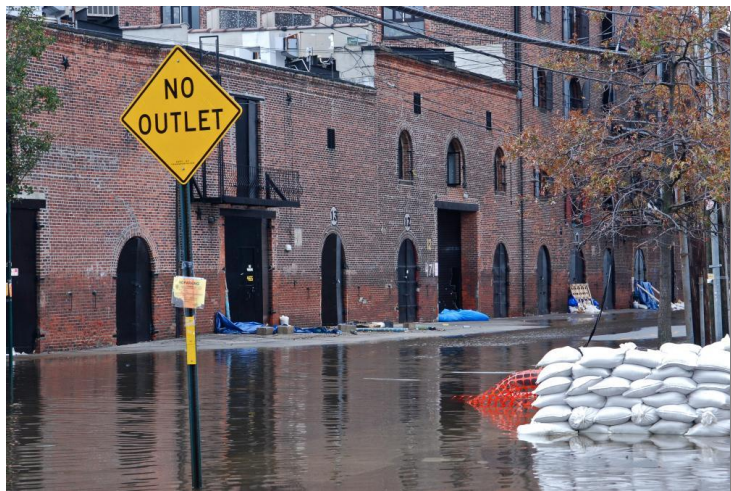
Figure 13- Flooding Caused by Sandy in Red Hook

Red Hook experienced significant flooding over much of the area. Flood depths of 3 to 4 feet were reported by business owners near the waterfront (Figure 13). Businesses and residences close to the waterfront or in relatively low-lying areas were particularly hard hit. Buildings, especially those with basements, suffered extensive damage to equipment, supplies, inventory, and personal belongings.

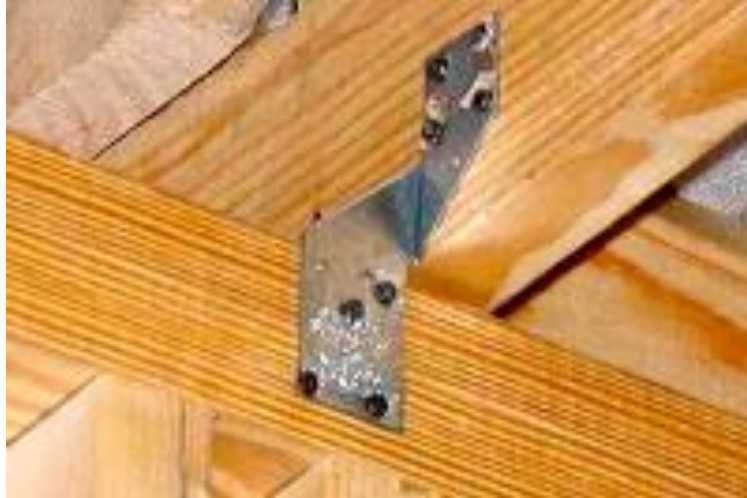
- Structural steel construction
 - Additional bolted connector plates
 - Replace existing welded connections with new, higher strength weld
- Concrete and masonry construction
 - Add steel connector straps attached to the concrete with new anchor bolts
- Timber construction
 - Replace existing connection hardware (nails or screws) with hurricane clips or a similar pre-formed connection device (Figure 15)

Figure 15 - Post construction hurricane clip to reinforce timber framing

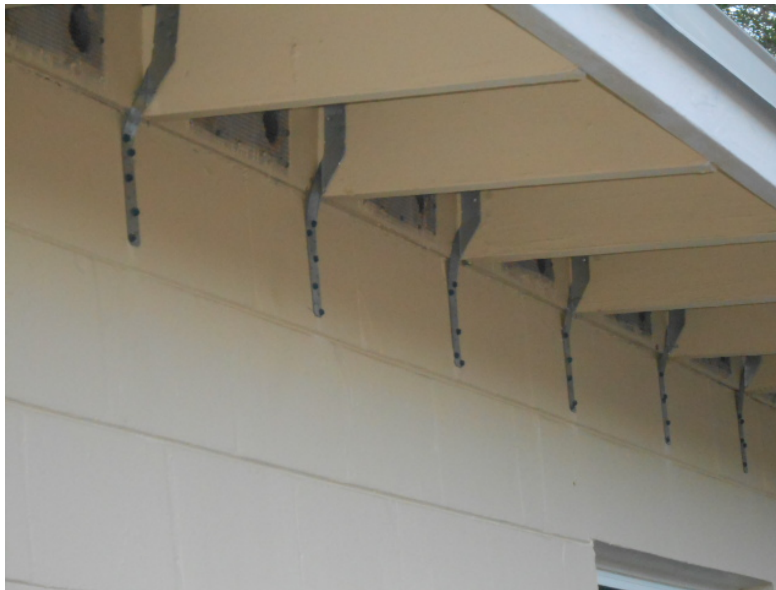
- Mixed material construction
 - The construction industry has developed a large inventory of connectors for reinforcing connections between dissimilar materials. Figure 16 shows a post-construction connection between timber framing and a concrete block wall.

Figure 16 - Hurricane clip reinforcement for timber frame to concrete block wall connection

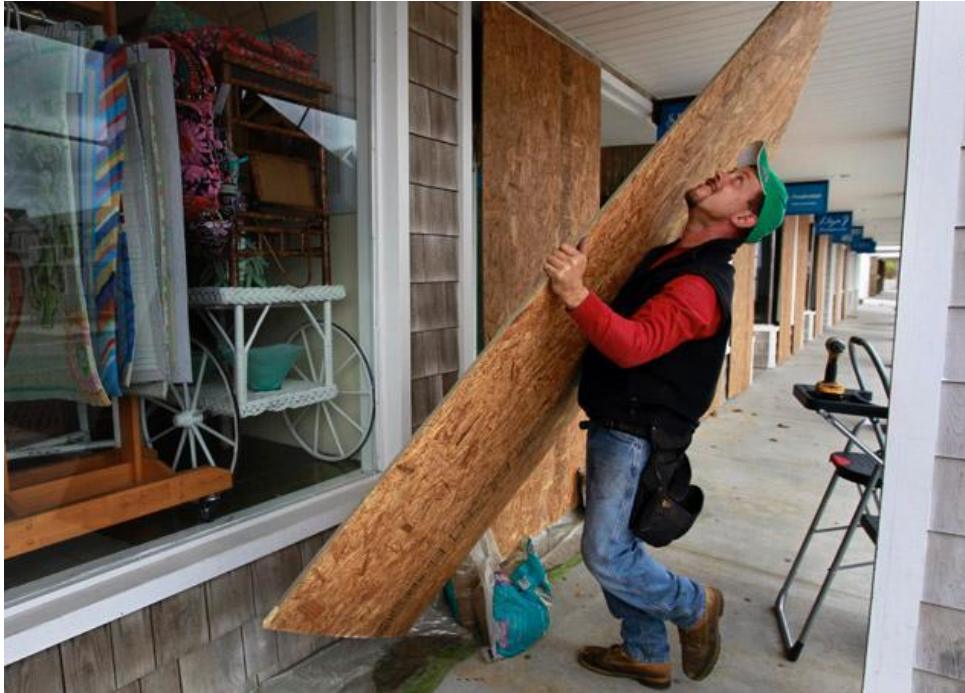
Wind-borne Debris Mitigation: Mitigation of wind-borne debris consists of protecting building openings and building exteriors using shutters or temporary impact-resistant shields. For windows not protected by metal security shutters, covering the outside of the window with $\frac{3}{4}$ -inch plywood panels is an effective mitigation measure. Where practical, the plywood panel should be fastened by being screwed into a wooden window frame, or into expansion anchors installed around the window opening.

Figure 17 - Boarding windows to prevent wind and water damage (Photo: NY Daily News)

1. Measure the window and add 7" to each edge measurement or whatever the frame will accommodate to provide overhang. Most lumber yards will cut $\frac{3}{4}$ " plywood sheets to specified measurements for free or a nominal charge.
2. After locating the framing studs and measuring carefully, drive #8 or #10 Phillips-head wood screws (at least 2-1/2" long) through the plywood and into the center of the studs above, below, and at the sides of each window or door (approximately 7/8" outside the window frame).
3. The screws must hit the studs solidly to provide an adequate anchor for the plywood shutter.
4. When protecting a door entrance or low window where water entry is a concern, spray foam can be applied around the opening for extra protection against water penetration.

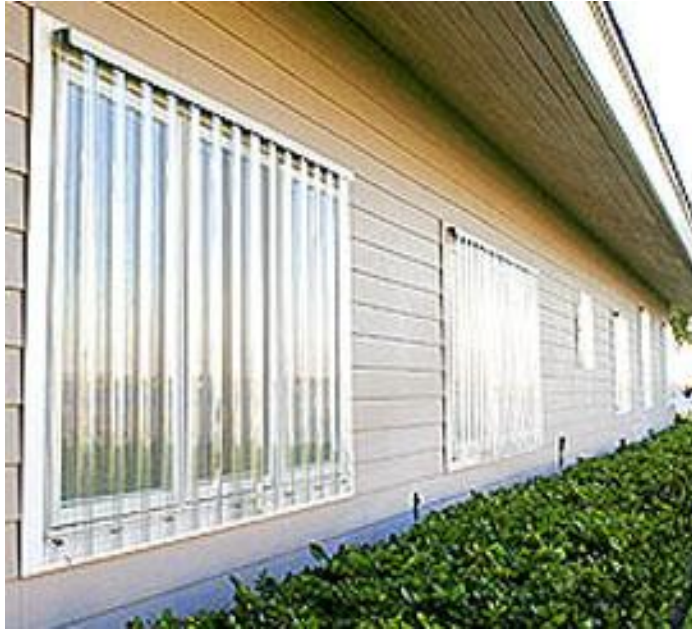
Figure 18 - Window storm shutters (Photo: Hurricane Shutters 2 Go)

More sophisticated pre-installed electric or manual crank storm shutters can cost \$50 to \$60 per square foot of window size. A set of shutters for a 3-foot by 4-foot window could cost about \$600 to \$720. The cost of a plywood cover will also depend on the size of the window. If the business's staff does the work, expect plywood to cost \$0.80 per square foot. Screws or lag bolts, including washers, will cost about \$0.10 to \$0.15 each. Protecting a window that is 3 feet wide and 4 feet high will cost about \$12. This figure covers only materials.

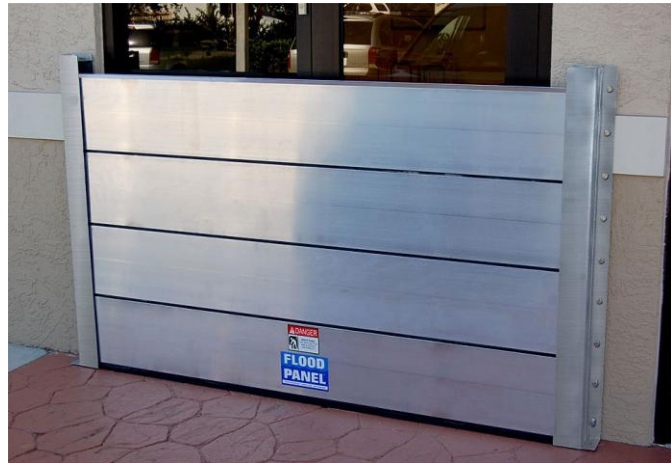
Flood barriers are the basic building block of floodproofing. Although permanent flood barriers are preferred, temporary flood barriers for doors and lower floor windows are a more feasible mitigation approach for the buildings observed in Red Hook. Door and window flood barriers are widely available in a wide range of sizes and configurations. Most temporary flood barriers require installation of barrier “logs” in the event of a flood threat. These temporary barriers are more effective than sandbags, easier to install when a flood is imminent, and require less storage space than sandbags. Figure 20 shows a typical temporary flood barrier installed in advance of a flood.

Figure 20- Temporary flood barrier installed across building door

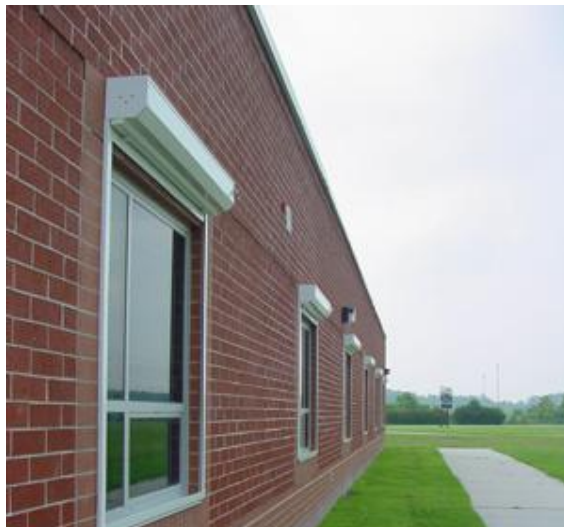
Figure 21 - Window shutters installed at a school/emergency shelter.

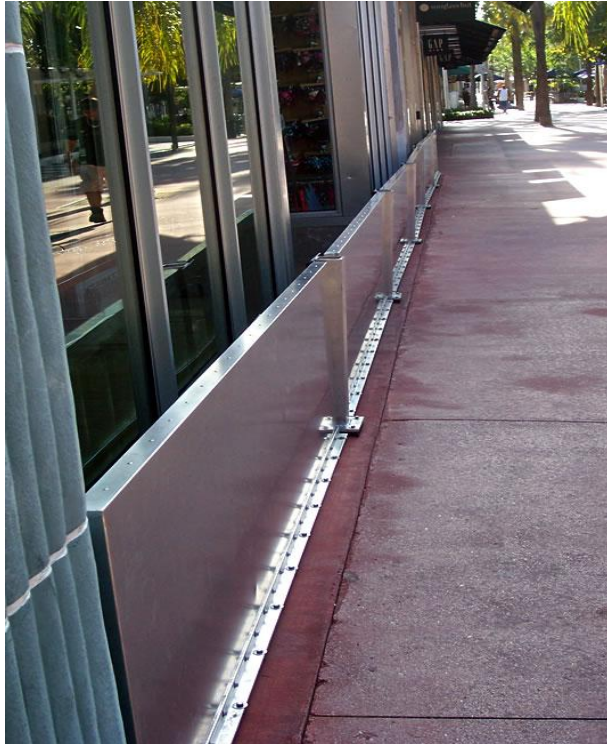
higher, not counting installation. Since many Brooklyn entrances and windows already feature security protection, some of these devices may not work or be practical for a particular building. Floodproof hatch openings to seal sidewalk entrances to basements are also available (Figure 24). Another simple approach to sealing sidewalk hatch-style doors in advance of a flood event is to have a pre-cut piece of $\frac{3}{4}$ -inch Plexiglas available on site to place in the door frame once all basement valuables have been evacuated. Upon placement of the Plexiglas, the edges can be sealed using a can of spray foam sealant. This approach may not be watertight, but it should prevent major basement flooding and is easy to install.

Figure 23 - Door shields protect entrances from low level flooding

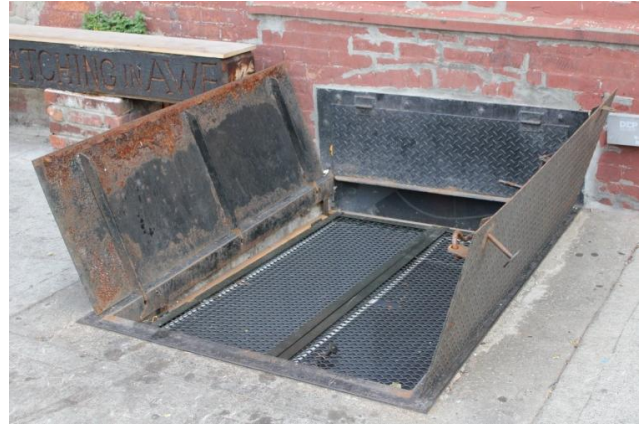
Figure 22 - Typical Brooklyn sidewalk hatch doors into basement

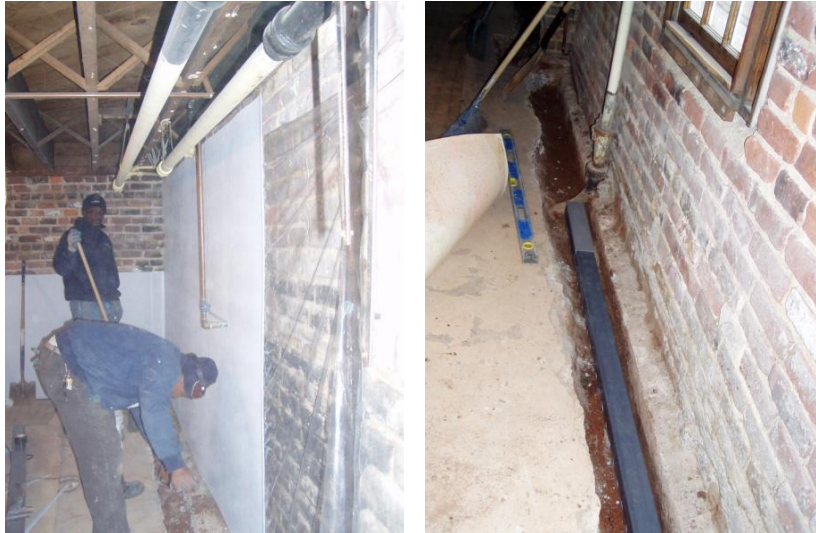
Interior construction generally requires a shallow excavation adjacent to the walls for installation of the drain line, and a collection sump with sump pump to discharge water to the stormwater sewer system.

Figure 25 – Installation of Interior Drainage System

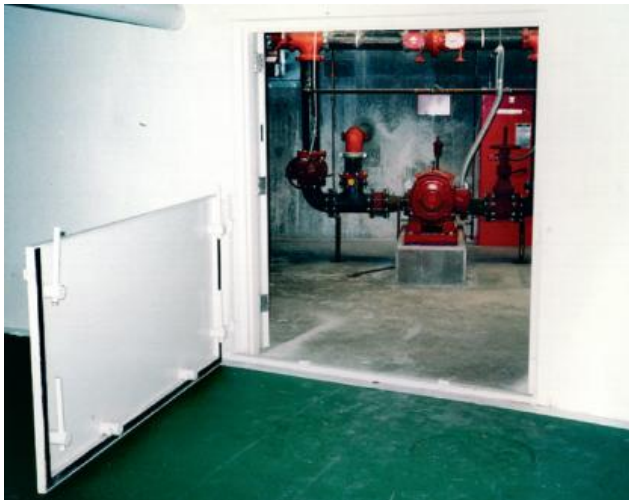
feasible, electrical switches, meters, circuits, receptacles, fixtures, and other components should be rewired with wiring suitable for submergence, and should not contain fibrous components. Some systems can be isolated in watertight interior compartments.

Figure 28 - Some mechanical systems can be protected with sealed compartments

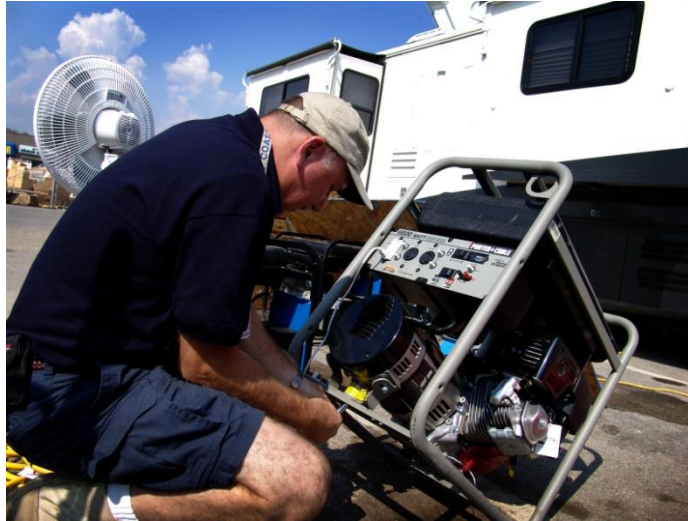
Portable, gasoline-driven generators are designed to be used with appliances with cords connected to them. Lights, small appliances, etc., can be plugged directly into outlets on portable generators. In general, they are not designed to be connected to building wiring. Property owners or occupants should not attempt to personally install these devices or connect them to building electrical panels.

Figure 29 – Portable Generator

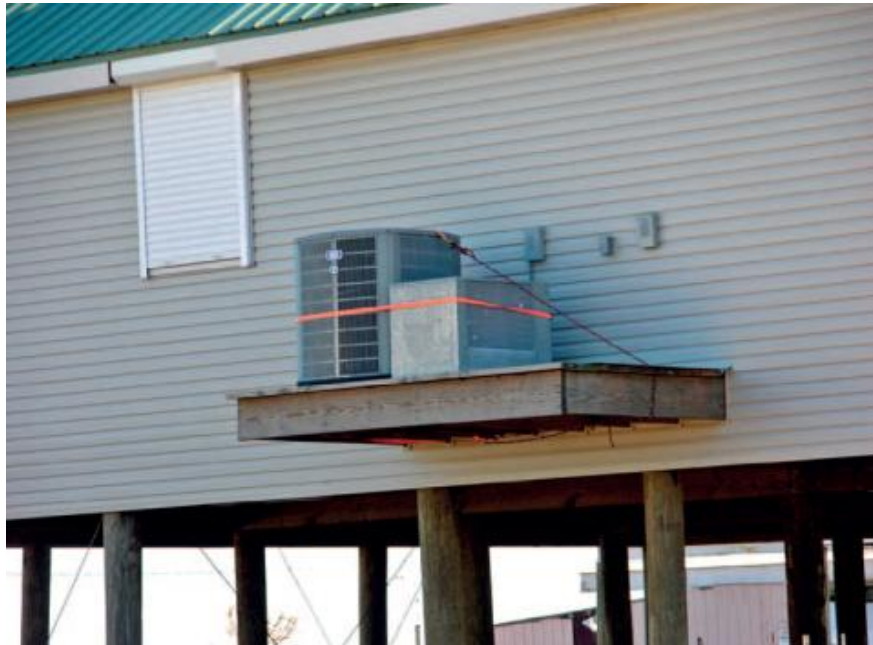
Heating, ventilation, and air-conditioning (HVAC) system components should be located above the BFE. Where elevating equipment is not feasible, floodproofing by constructing a watertight enclosure with adequate ventilation through a grated roof may be a feasible alternative.

Figure 31 - Elevation of air conditioning condenser in a floodprone area; additional anchorage is recommended (FEMA P-55)

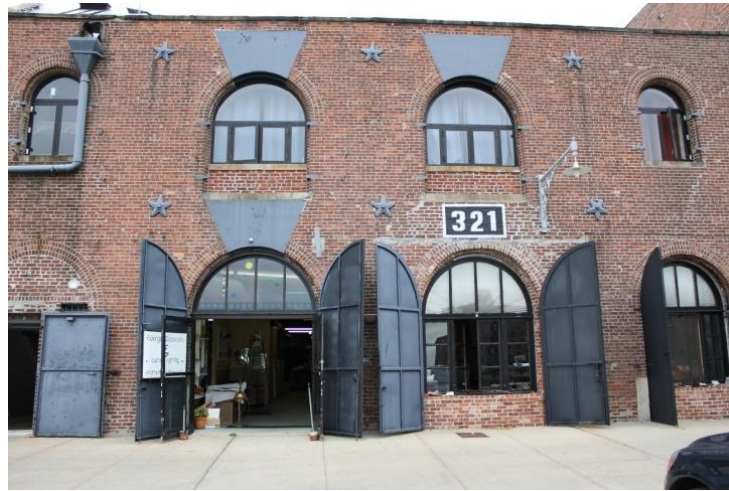
Figure 32 – Light manufacturing business facility

The business leases space in a renovated storage building on the Red Hook waterfront. The two- and three-story masonry building measures 480 feet long by 144 feet deep. The business leases a ground-floor module measuring 50 feet by 144 feet (Figure 32). Doors and windows are located in openings originally designed for horse-drawn carts. In many front entrances of the units leased in this building, an entire opening is used as a decorative entrance. In other cases, the original opening has been closed with brick masonry to match the existing facade, with new openings formed for windows and pedestrian doors.

Although the business masonry walls separate each tenant, each wall has one or more heavy steel rolling doors hanging on tracks attached to the walls. The doors are not watertight and allow floodwater and water from the interior sprinkler system to flow between units.

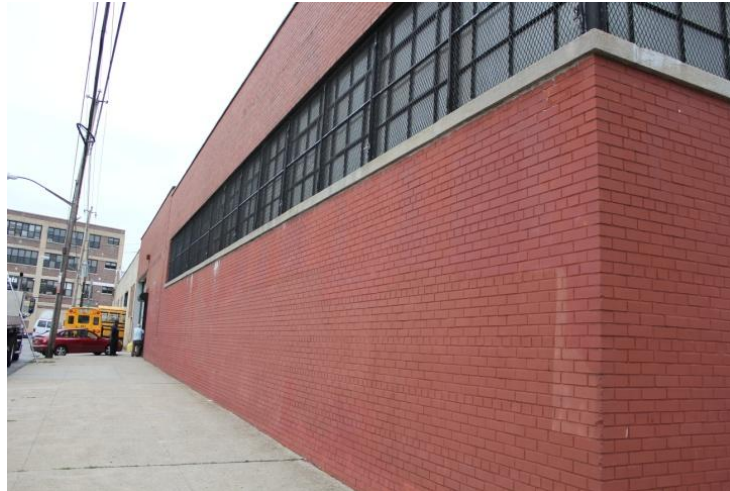
Figure 35 – Mid-size manufacturing business facility

Business Description: The mid-size manufacturing Case Study represents a business that makes systems parts from high grade steel and specialty metals, primarily for the aerospace industry. The business owns a one story, high-bay, masonry building. The building, located a few blocks from the waterfront, measures 125 feet long by 100 feet deep (Figure 35).

Although entrances to the building are at street level, the interior main operations floor is elevated about 3.5 feet above the street level. A vehicle access door provides street-level access into a “cut-out” area for unloading large steel bars used as raw materials as well as loading manufactured product for shipping.

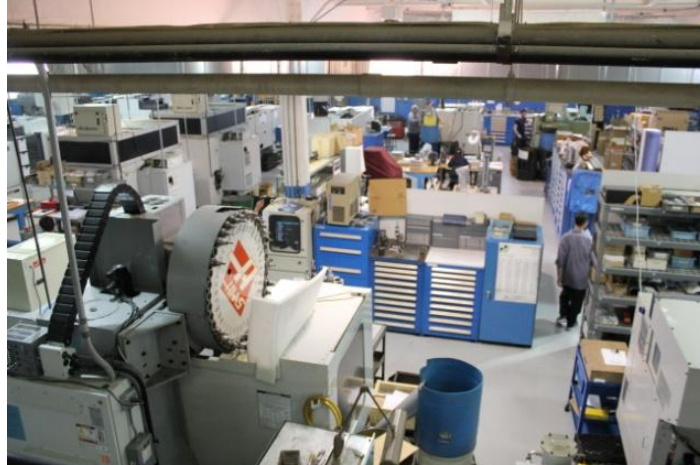
Figure 36 – Mid-size manufacturing main production floor

The main plant floor contains computer controlled metal turning and milling machines, quality-control measuring stations, drawings and specifications for parts, and finished products (Figure 36). The main floor is partially mitigated against flooding because it is on a level about 3 feet above the street elevation, which is accessed by stairs at both exterior pedestrian entrances. Office space for management and technical staff is located on an upper mezzanine level.

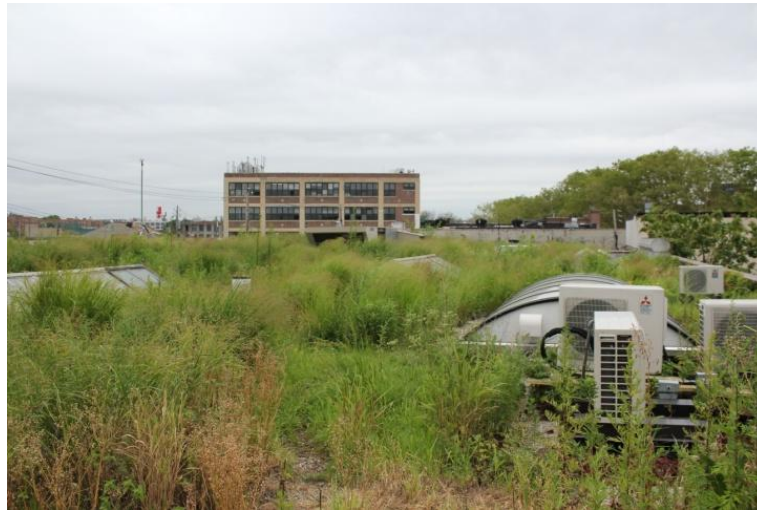
- Install backflow preventer in the sewer line
 - The building has a “green roof” with a vegetative cover (Figure 38). Roof drainage is connected to the building’s sewer system. During floods, if a backflow preventer is activated, the roof drain may cause backflow into plumbing appliances on the lower floor, or fail to drain adequately, resulting in excess water weight on the roof
 - If the backflow preventer is installed, a roof rain shutoff valve should be installed to prevent overflows
 - Add weep holes to the roof parapet to provide emergency drainage from the roof
- Revise configurations for storing small tools and equipment, particularly gauges and calibrated measuring devices, to an elevation above the BFE

Figure 38 - Case Study 2 green roof

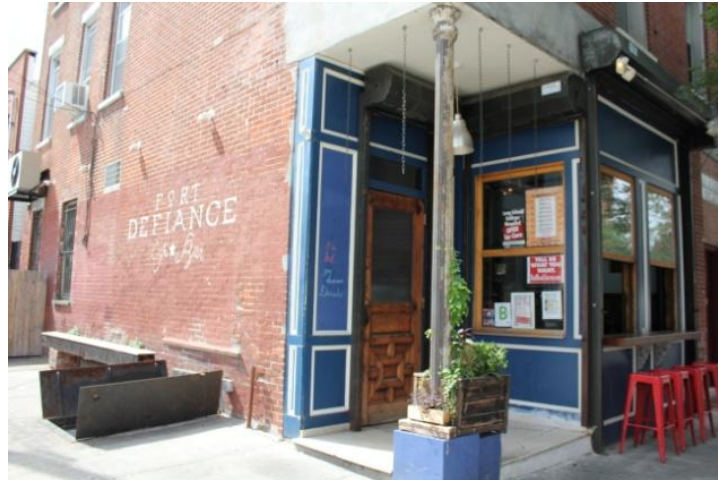
Figure 39 – Corner café and bar

Business Description: The restaurant Case Study is locally owned and operated single-location café and bar. The business leases the first floor and basement of a three-story masonry building (Figure 39).

Customer seating, food preparation, and serving are confined to the first floor. The basement is used for storage of food, beverage inventory, and critical operating equipment including the main ice making machine, water filtration system, and cooler compressors. A small office area is also in the basement.

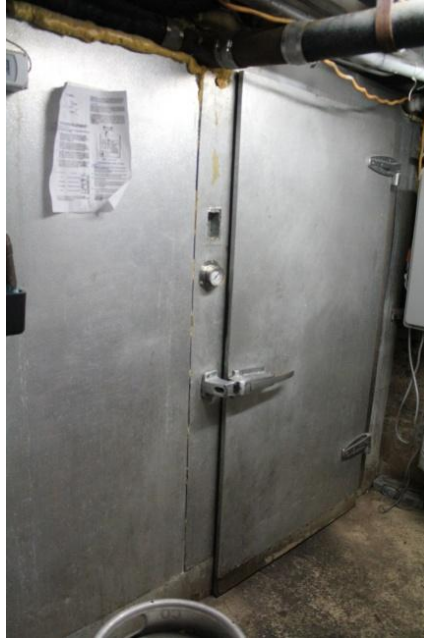
- Develop a more prescriptive plan to evacuate the basement equipment, stock, and supplies before a predicted severe storm event
- Disconnect and evacuate basement equipment where feasible; empty the walk-in cooler unit of perishable food; move heavy equipment into the walk-in cooler unit, and assure door gasket remains water tight. (Note: the basement food cooler remained sealed during Sandy.)

Figure 40 - The watertight cooler can be re-purposed to store essential equipment before floods.
